Flue Duct Expansion Joint Inspection 09-04

EJ-24B

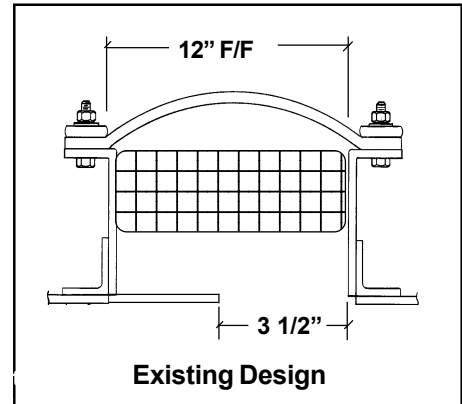
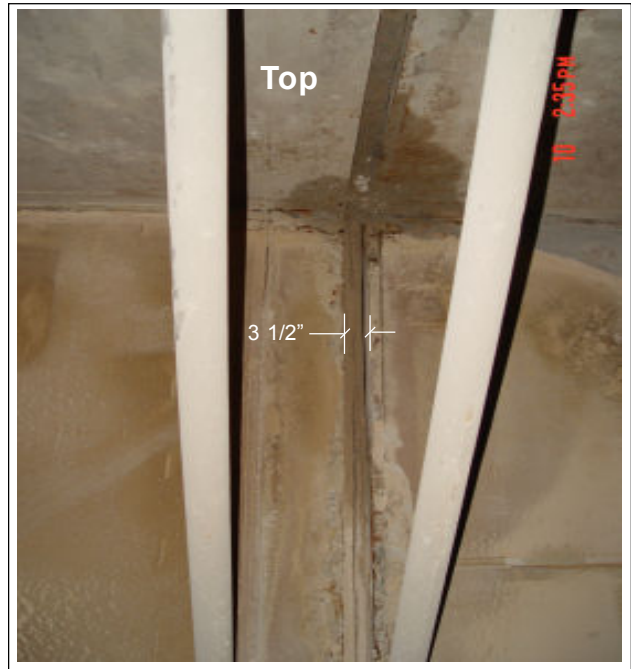
EJ-24B

Expansion joint shows signs of abrasion to the insulation pillow cover and internal insulation. If left unattended this will result in the premature failure of the expansion joint. The damage was caused by the 3 1/2" gap at the flow liner.

1. Install new 3" high density insulation pillow in the bottom and a 2" pillow on sides & top.
2. Install new 1/4" flow liners that cover entire breach opening on all sides.
