Flue Duct Expansion Joint Inspection 09-04

EJ-24B

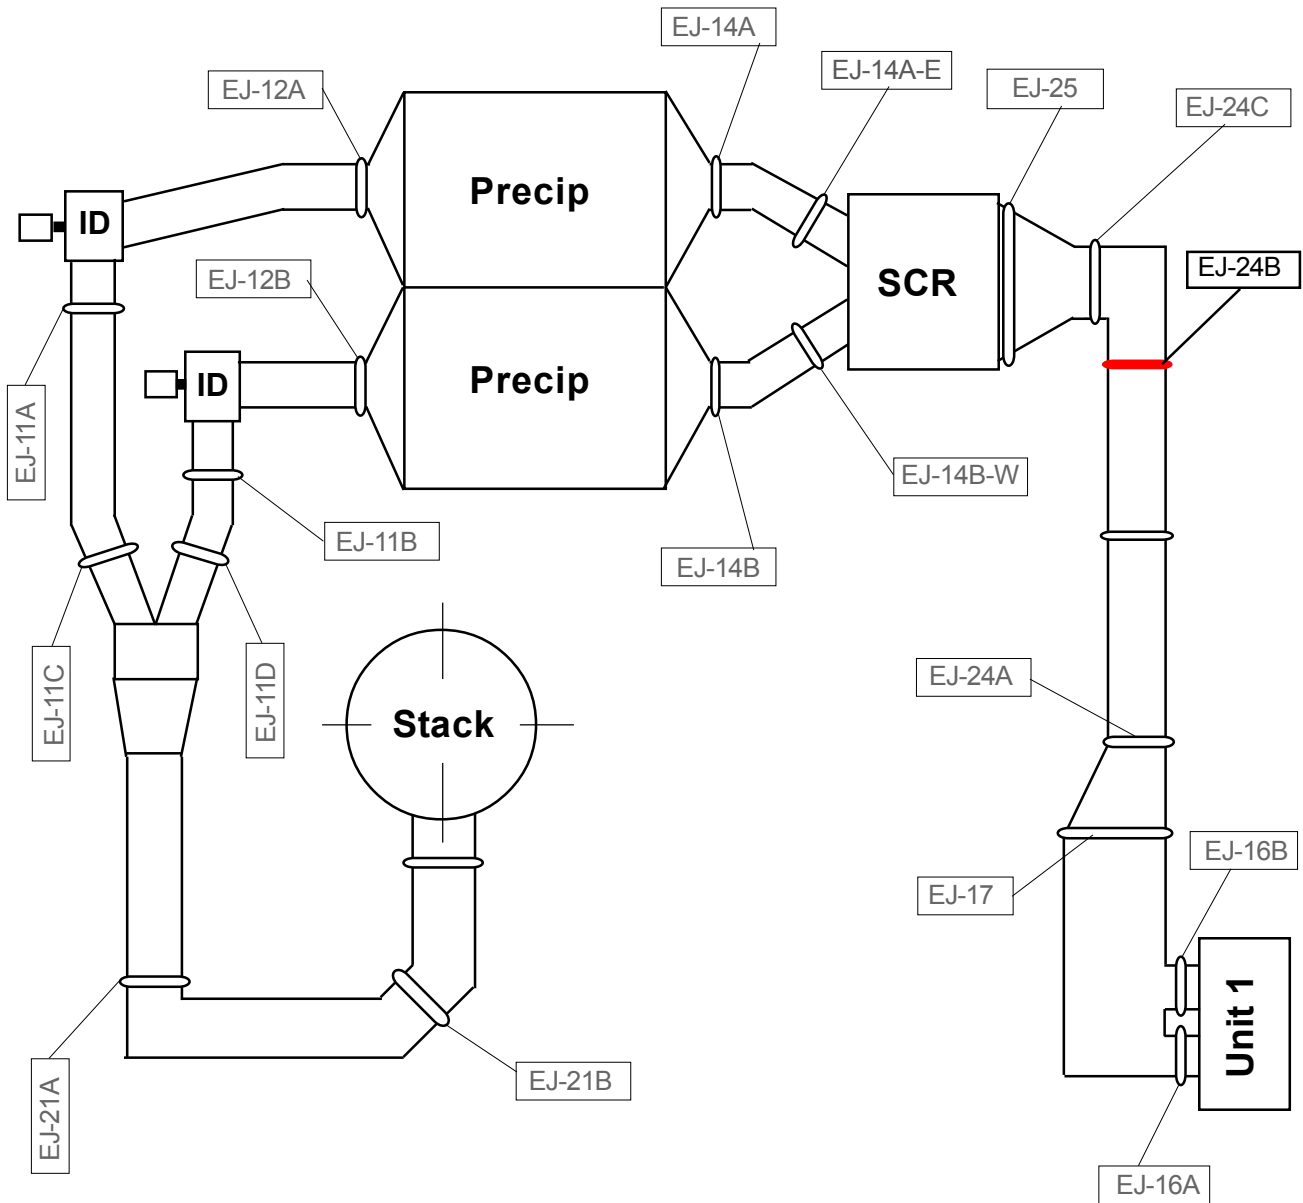
Expansion joint shows signs of abrasion to the insulation pillow cover and internal insulation. If left unattended this will result in the premature failure of the expansion joint. The damage was caused by the 3 1/2" gap at the flow liner.

1. Install new 3" high density insulation pillow in the bottom and a 2" pillow on sides & top.
2. Install new 1/4" flow liners that cover entire breach opening on all sides.
